Manhole Inspection Summary

Manhole # S37Y1_001MH

Insp Date: **11/16/07 10:04 AM**

Location Address: **3819 S Hanover St**

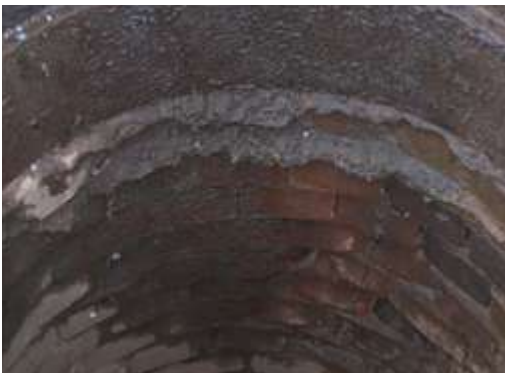
Defect 2

Infiltration: ☐ None ☐ Joint ☐ Cracks ☒ **Mortar** ☐ Roots ☐ Wall

Chimney intrusion

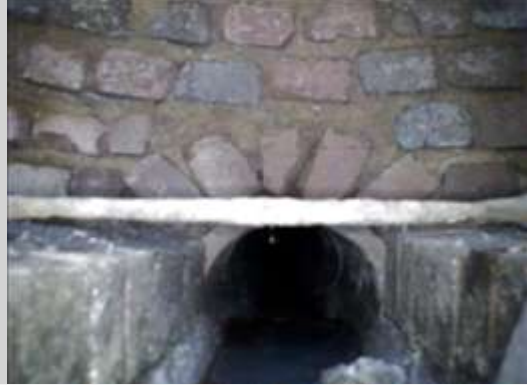
12 O'Clock Outflow

Pipe Height: **8.4** (in.) Rod and Bar (Angled)
Pipe Material: **Clay** ☐ Pipe Lined
Invert Depth: **10.50** (ft.) Flow Characteristics: **Fast**
Deposits: ☒ None ☐ Mud ☐ ~~Gravy~~ ☐ Debris ☐ Grease
Silt Depth: (in.) Deposits Extent:
Infiltration: **None** Pipe Seal Cond: **Sound**

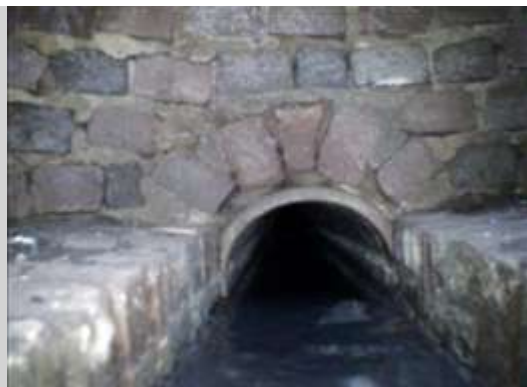
6 O'Clock Inflow

Pipe Height: **8.4** (in.) Rod and Bar (Angled)
Pipe Material: **Clay** ☐ Pipe Lined
Invert Depth: **10.12** (ft.) Flow Characteristics: **Slow**
Deposits: ☐ None ☐ Mud ☒ ~~Gravy~~ ☐ Debris ☐ Grease
Silt Depth: **1** (in.) Deposits Extent: **Light**
Infiltration: **None** Pipe Seal Cond: **Sound**
